Beyond Event Data Recorders: Analysis of Vehicle Safety Systems in Support of Accident Reconstruction

By William Jennings, Jenish Engineering Limited, Oshawa

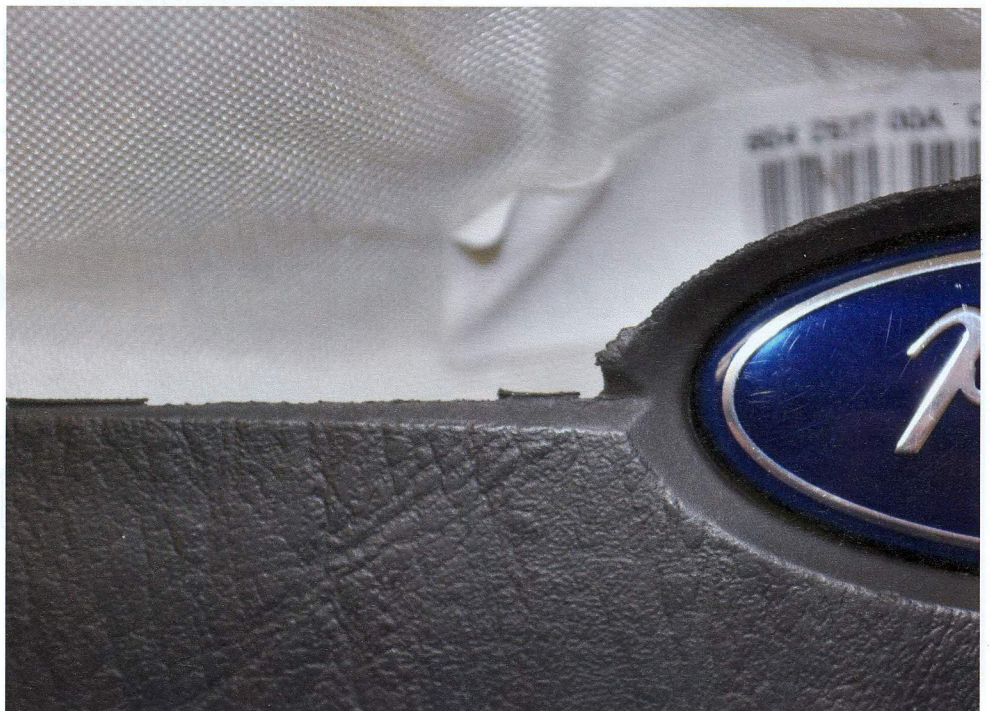
Figure 2. A close-up view of an airbag that was legitimately deployed in a controlled environment. The seam of the airbag door exhibited a slightly jagged appearance after deployment, and no cut lines were evident in the area around the centre emblem.

will not be possible to determine whether an apparent airbag deployment was legitimate. That assumption would be wrong! It is very difficult, if not nearly impossible, to leave no clues of the false deployment of an airbag, or other deployable restraint. Careful examination of the airbag modules and the vehicle's electrical wiring can often provide clues to the legitimacy of the deployment. For example, the proper deployment of an airbag will often result in slightly frayed or jagged edges along the seam of the airbag cover, where the inflating airbag is designed to tear through as it deploys. Inspection of that seam may reveal faint cut lines or very clean edges, indicating that the airbag door was purposely cut open and the airbag simply pulled out. Other examples have been seen to be crudely cut out, not even following the correct embossed seam that the airbag is designed to deploy through. Photographs showing a properly deployed airbag and some that were cut out are shown in Figures 1 to 4.

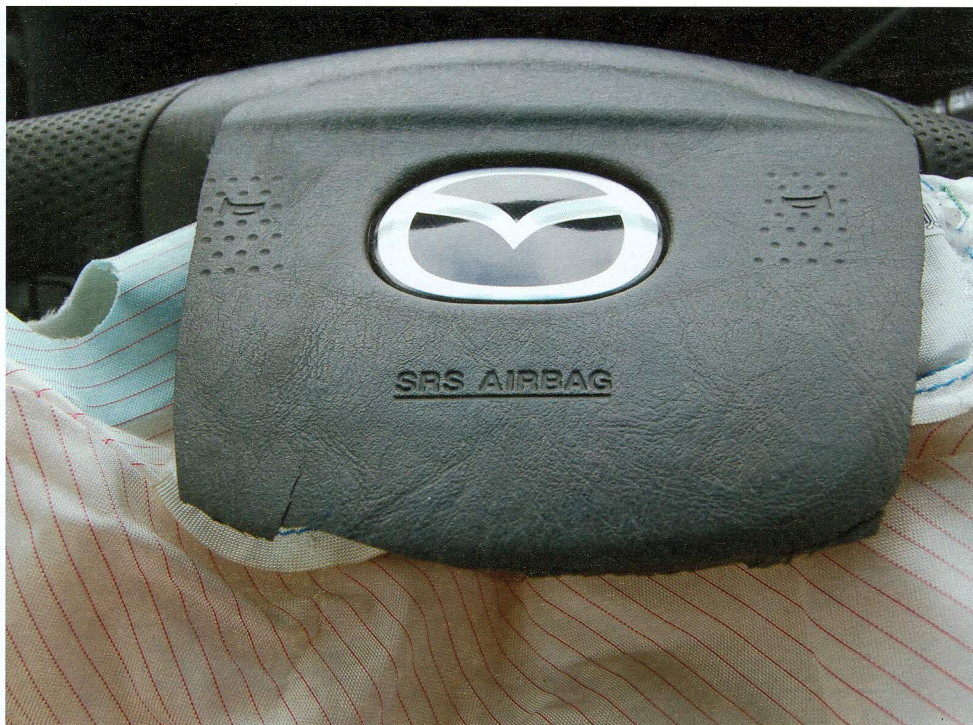
Figure 3. This driver airbag exhibited a very crudely cut airbag cover. Note the uneven profile along the bottom edge.

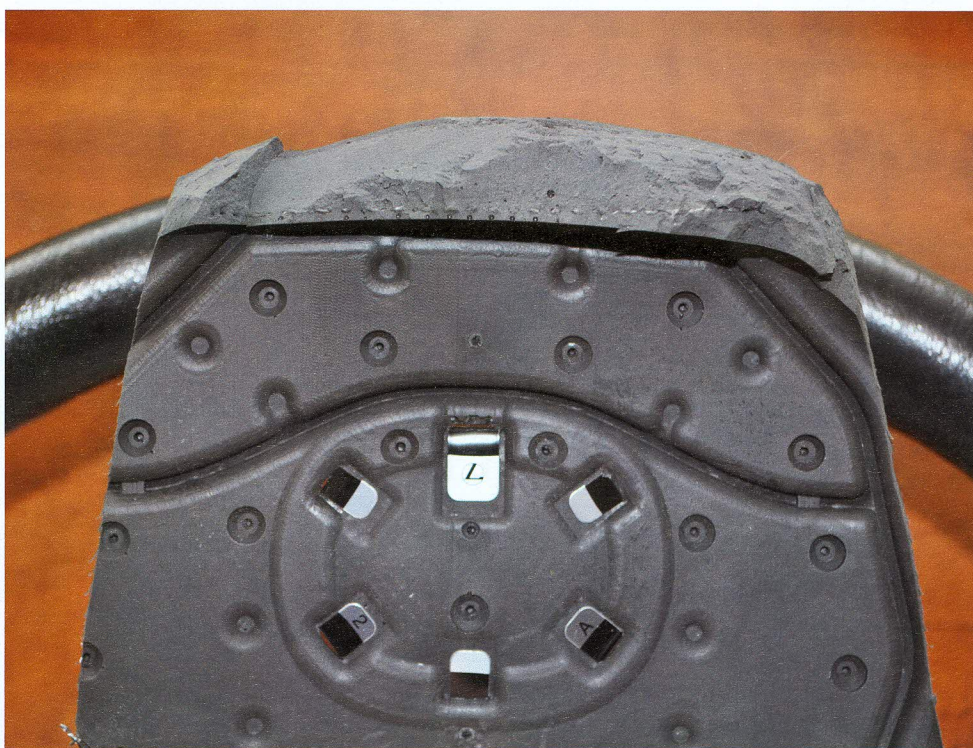
Figure 4. A view of the underside of the driver airbag door from the same airbag as shown in Figure 3. The bottom edge of the door (top of photo) is very roughly cut, and the airbag clearly did not deploy through the embossed seams that were moulded into the back side of the airbag cover, as designed. This airbag was also removed, tested and shown to be "live."

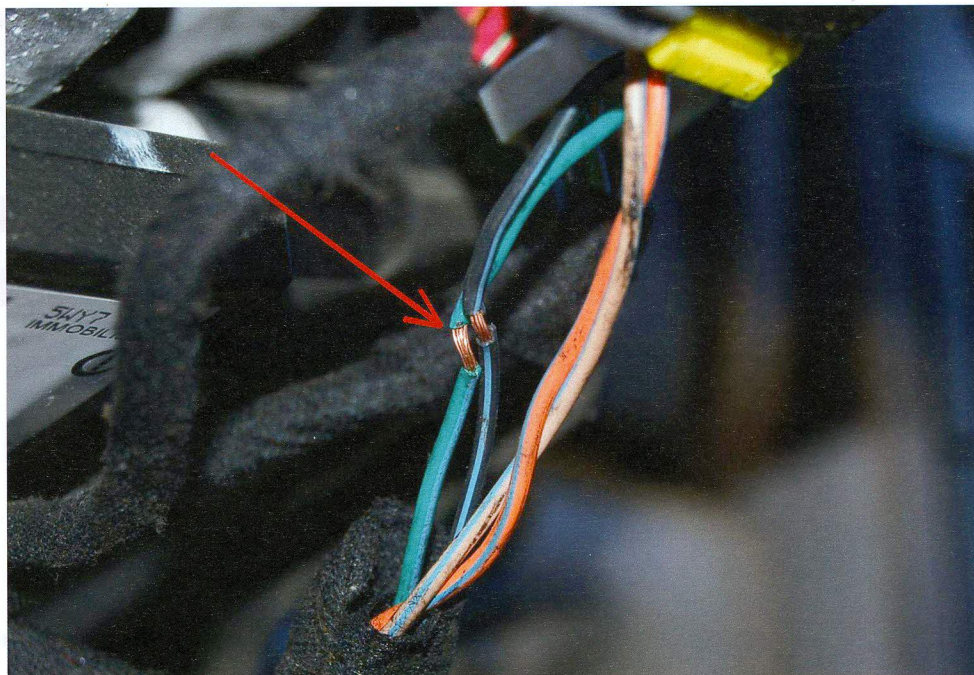
Figure 5. The airbag electrical wiring on this vehicle was carefully stripped and peeled back, exposing the copper conductor, allowing an electrical current to be applied directly to the airbag module.

Additionally, inspection of the airbag wiring may reveal areas where the wiring has been compromised, to allow for an electrical current to be supplied directly to the airbag module, and thereby cause a false deployment. We have found cases in which the wiring leading to an airbag circuit has been cut and stripped, as well as cases in which the insulation has been carefully peeled back to expose the wiring within. Figure 5 shows an example in which the wiring insulation was pulled back to gain access to the airbag circuit. Removal of interior trim panels and other components is usually required to root out some of the methods used to falsely deploy an airbag. However, in many

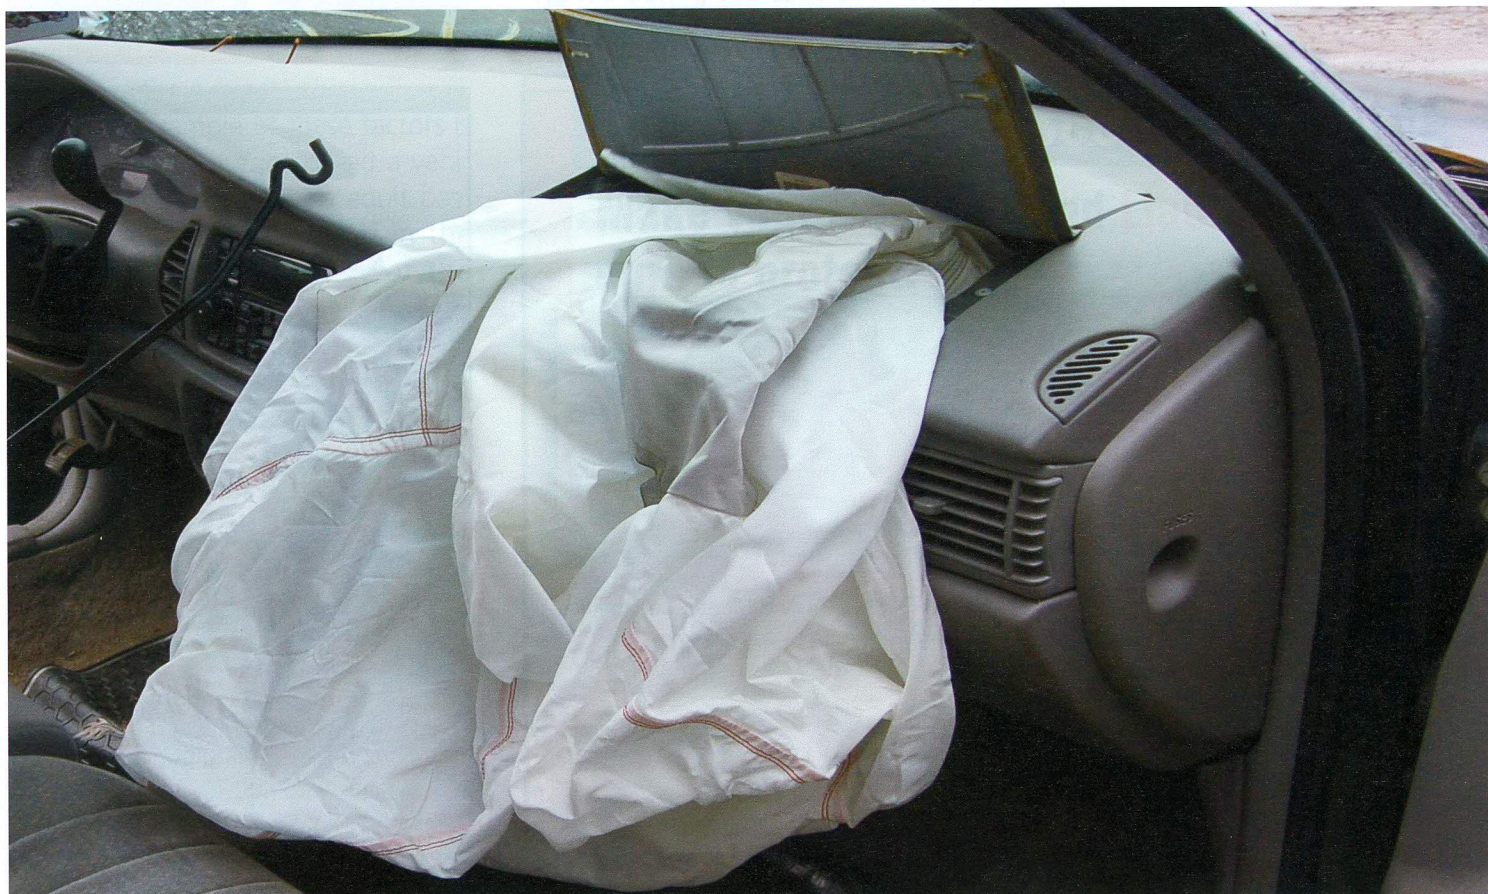
Figure 6. This vehicle was found with the airbags hanging out in the “deployed” condition, while the EDR recorded only a non-deployment event. The airbags were then removed and preserved for future testing.

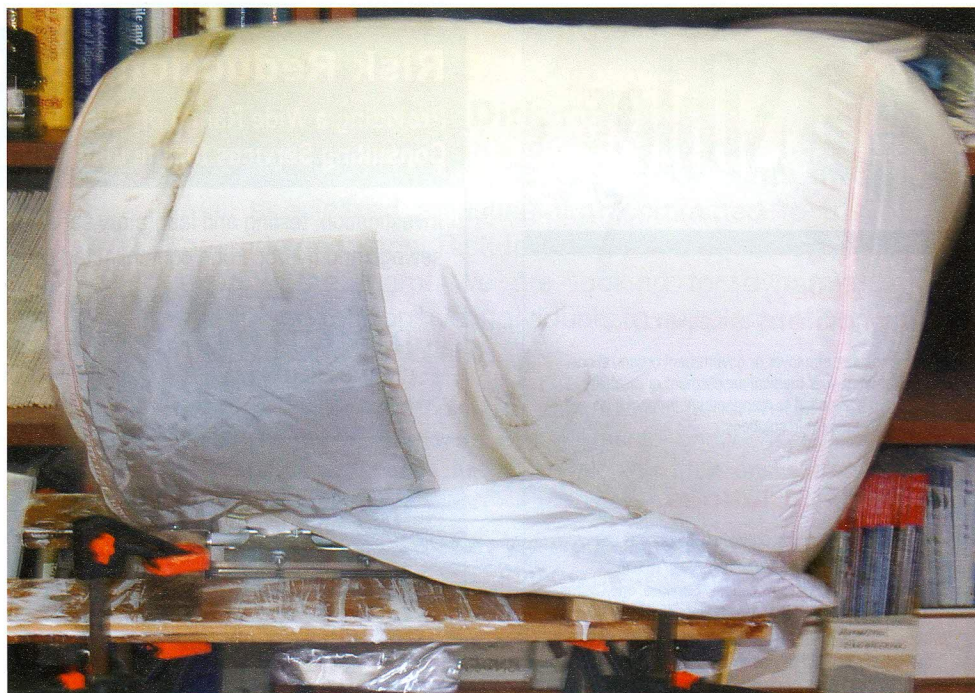
Figure 7. The airbag shown in Figure 6 was deployed in a controlled environment, and recorded with video and photographs. Despite the deployed appearance of the airbag within the vehicle, the airbag clearly inflated during the controlled test, proving that it did not deploy during the reported collision.

or not the airbag is still “live,” or if it has been deployed. If the subject airbag is deemed to be “live” or undeployed, despite its appearance of being a deployed airbag, irrefutable confirmation can be achieved by physically deploying the airbag in a controlled environment, at the request of the client. As stated above, airbags are single-use commodities, and they cannot be deployed twice. If it goes “bang” in the controlled test, it surely didn’t deploy during the reported collision, regardless of any claims to the contrary. Figures 6 and 7 show an airbag that we found in an apparently deployed condition, which was later deployed when removed from the vehicle.
